Living with the West Florida shore

Larry J. Doyle, Dinesh C. Sharma, Albert C. Hine,
Orrin H. Pilkey, Jr., William J. Neal, Orrin H. Pilkey, Sr.,
David Martin, and Daniel F. Belknap

Duke University Press Durham, North Carolina 1984
Property of CSC Library

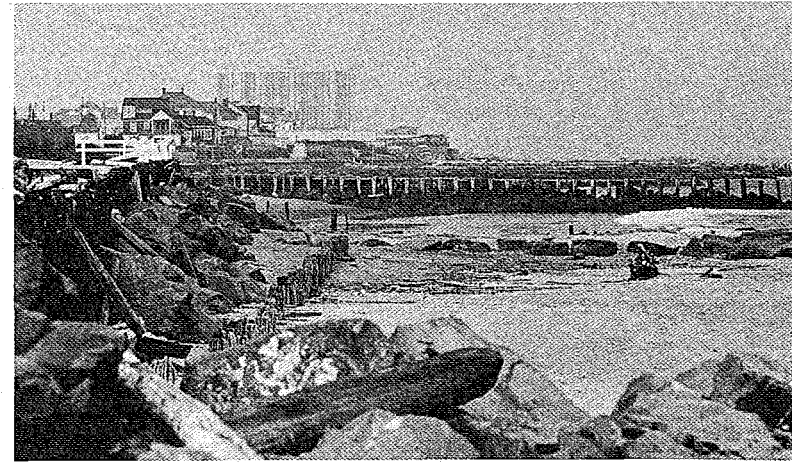
Fig. 4.12. New Jerseyization!

Today Cape May is no longer found on anyone's list of great beach resorts. The problem is not that the resort is too old-fashioned, but that no beach remains (fig. 4.12).

6. Once you begin shoreline engineering, you can't stop it! This statement, made by the city manager of a Long Island Sound community, is confirmed by shoreline history throughout the world. Because of the long-range damage caused to the beach it "protects," once engineering starts it must be maintained indefinitely. Failure to allow the sandy shoreline to migrate naturally results in a steepening of the beach profile (down to a depth of 30 or more feet) reduced sand supply, and, therefore, accelerated erosion (see chapters 2 and 3). Thus, once man has installed a shoreline structure to protect the beach, "better"—larger and more expensive—structures must subsequently be installed, only to suffer the same fate as their predecessors (fig. 4.12).

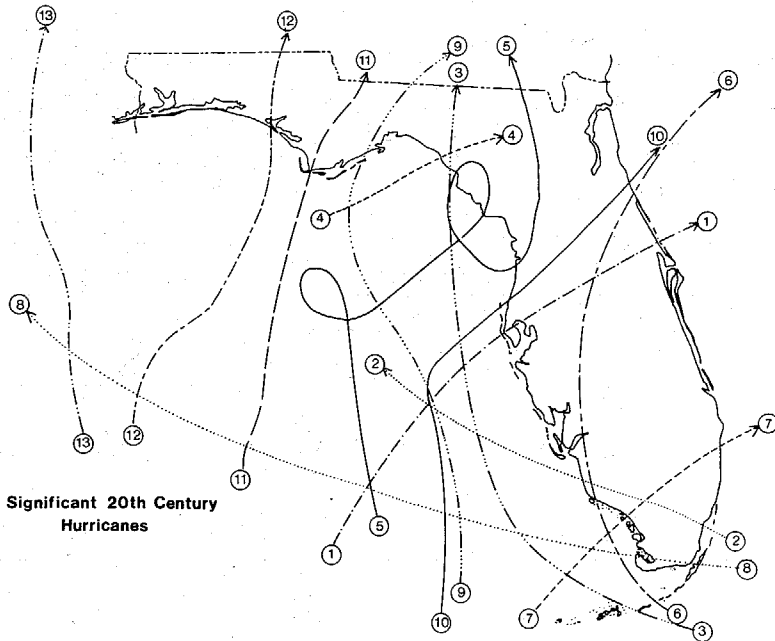
Fig. 5.1. Hurricane tracks off Florida: 1. October 21–31, 1921; 2. September 6–22, 1926; 3. August 31–September 8, 1935; 4. August 31–September 2, 1937; 5. September 1–7, 1950; 6. September 3–13, 1960 (Donna); 7. October 8–17, 1964 (Isabell); 8. August 27–September 13, 1965 (Betsy); 9. June 4–14, 1966 (Alma); 10. October 20–29, 1968 (Gladys); 11. June 1972 (Agnes); 12. September 1975 (Eloise); 13. August–September 1979 (Frederic).

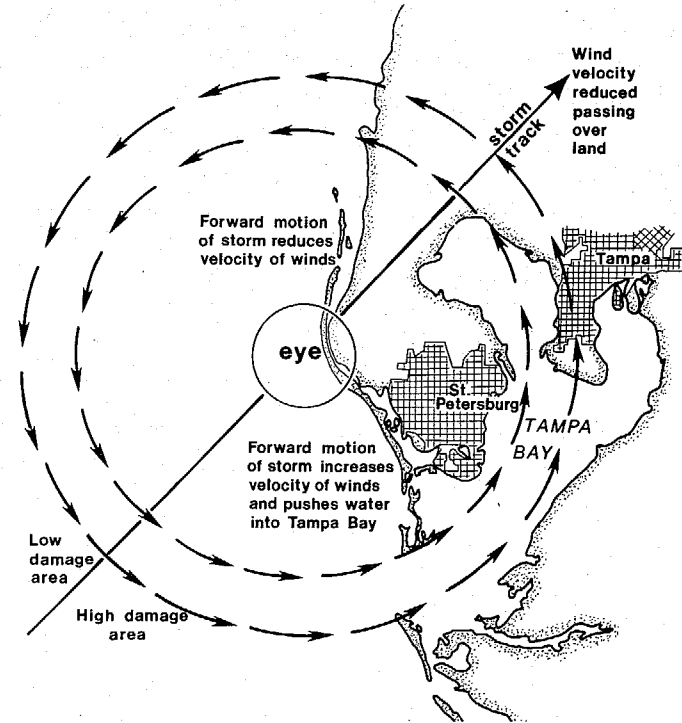
Fig. 5.2. The most dangerous potential hurricane track. If such a storm occurs, a great deal of flooding will result in St. Petersburg and Tampa; hundreds of thousands of people will have to evacuate.

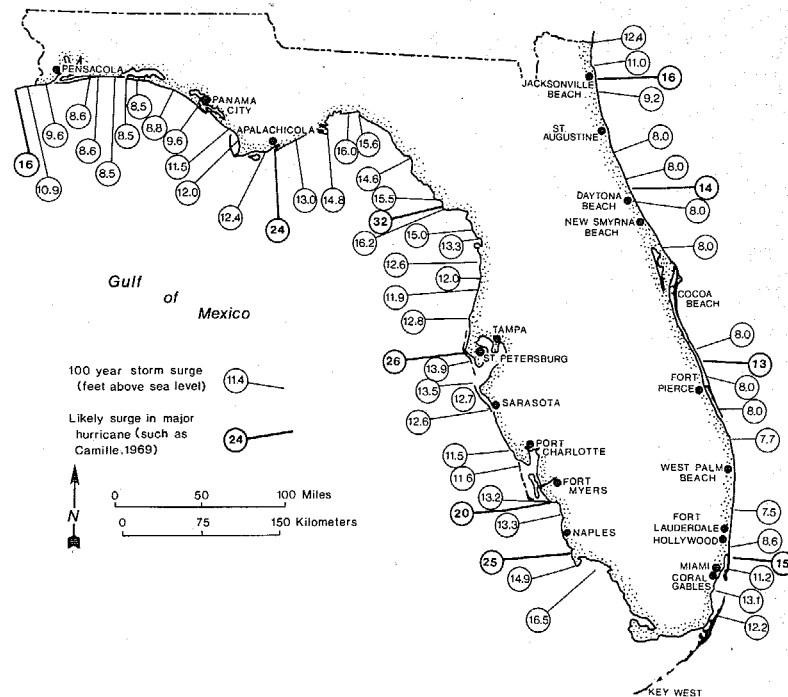
**Fig. 5.3.** Storm-surge map for Florida. Modeled after "Hurricane Survival," NOAA Coastal Hazards Program.

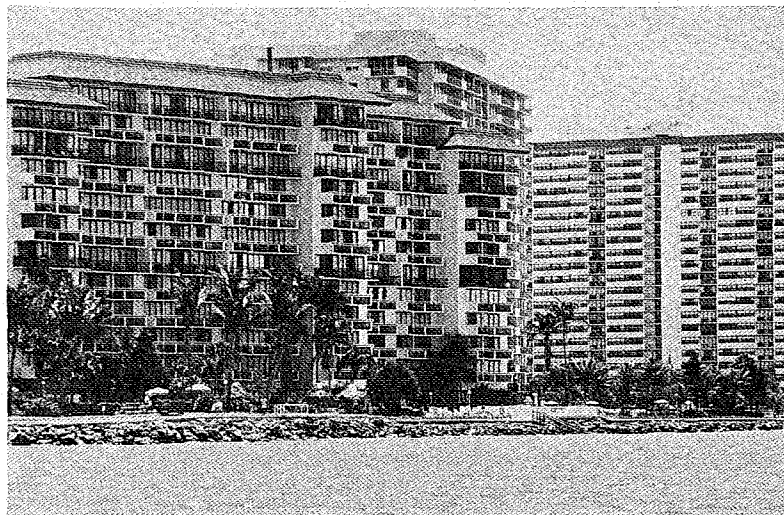
Fig. 5.4. Very tall buildings on the very low Marco Island. Photo by Al Hine.

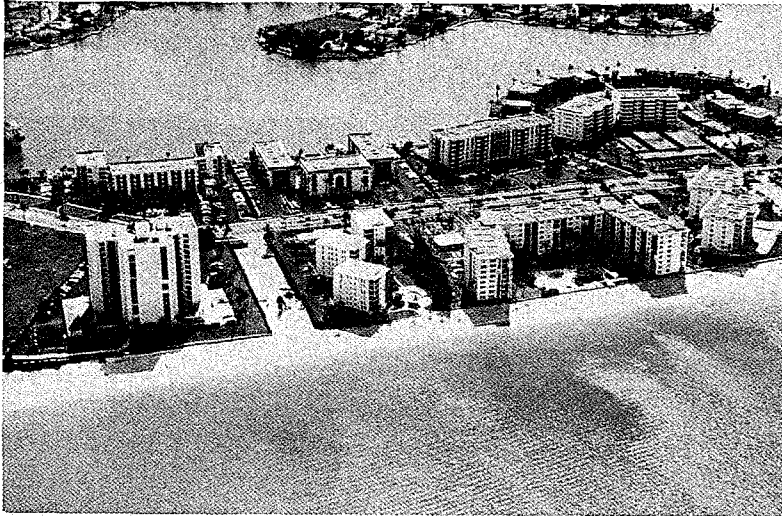
Fig. 5.5. Tall buildings hugging the beach on very low building sites at Naples, Florida. Photo by Al Hine.

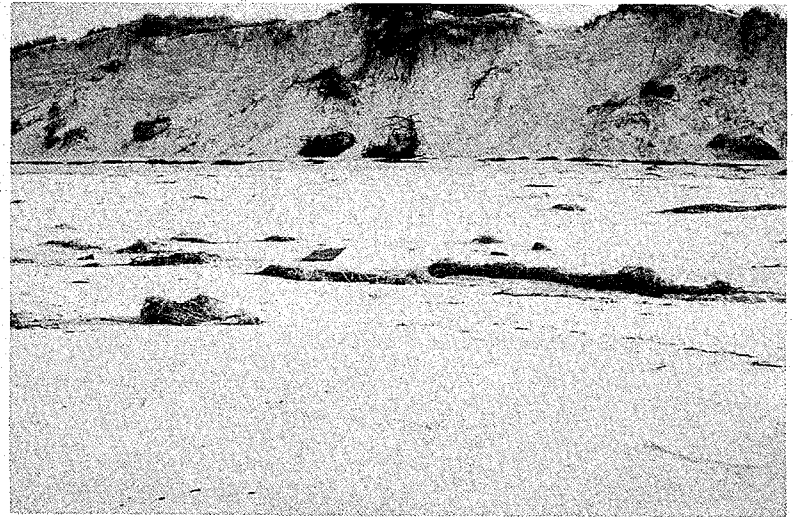
Fig. 5.6. This was Panama City Beach after Hurricane Eloise (1975). The dunes were cut back more than 50 feet, but since no seawalls were located here the beach remained broad and healthy. Photo by Bob Morton.

have some rows of dunes between you and the forces of the sea (figs. 5.6 and 5.7). Dunes form by wind blowing sand in shore from the beach. Primary dunes or the first row of dunes are the most important and should be protected at all costs. Examples of a well-developed primary dune system can be seen on St. Joseph Spit in Gulf County. Unfortunately, many if not most primary dunes have disappeared on West Florida's developed islands (fig. 5.8).

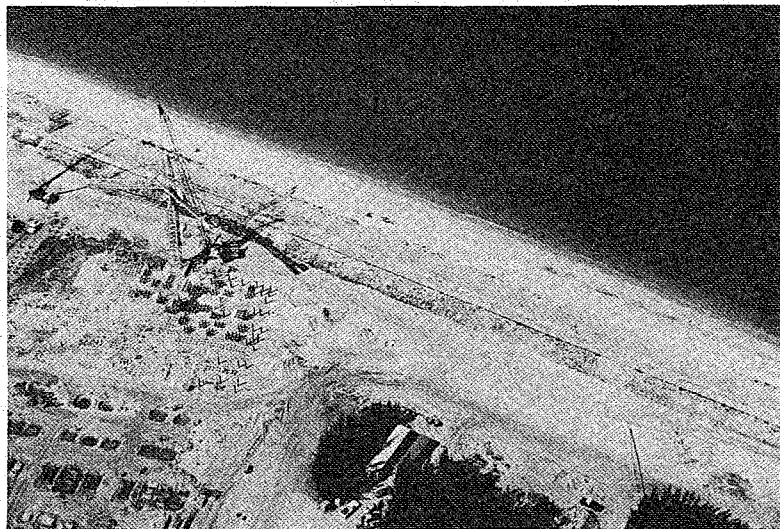
Fig. 5.7. Artificial dune in front of a condo construction site near Naples, Florida. Artificial dunes do not act like natural dunes. This dune line might better be called a sand dike! Photo by Al Hine.

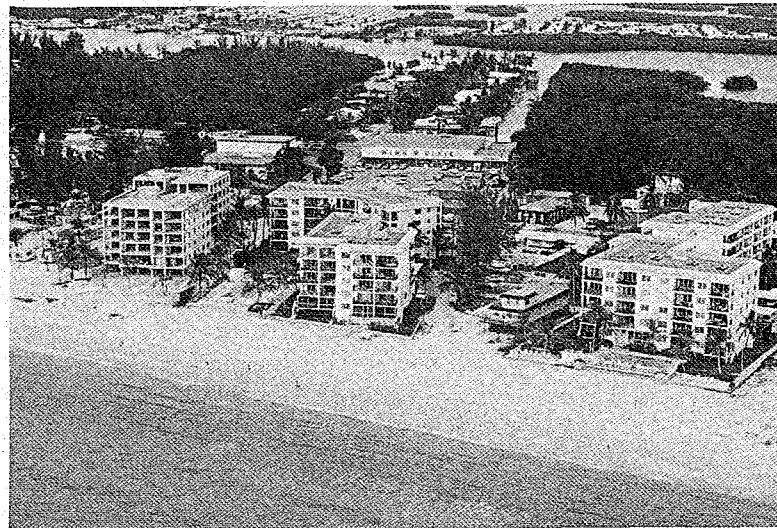
Fig. 5.8. Dunes were removed from this section of Fort Meyers Beach and replaced by buildings and seawalls. Photo by Dinesh Sharma.

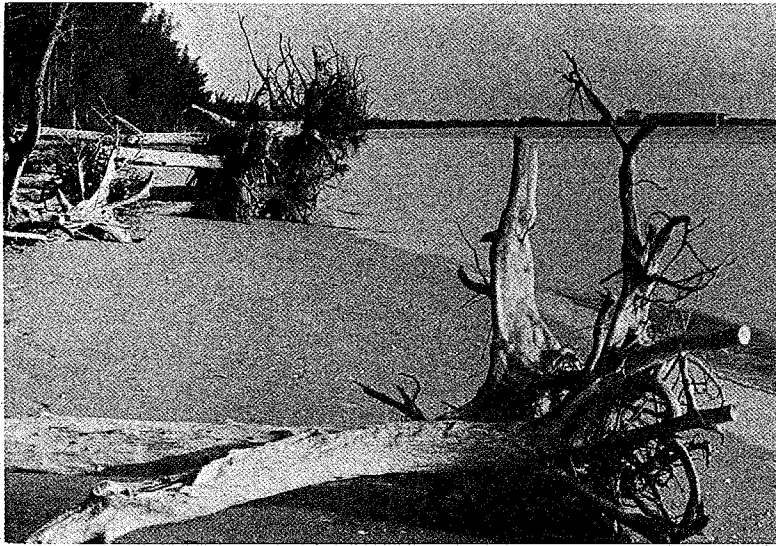
Fig. 5.9. Lovers Key after a June 1982 storm. Australian pines are poor erosion buffers because of their shallow root systems, as can be seen from these stumps. Australian pines also are poor dune builders, and on the shorefront they should be replaced by native vegetation. Photo by Dinesh Sharma.

unfortunately they are now considered to be unwelcome intruders. They have shallow root systems and are easily blown over or knocked over (fig. 5.9). They do not stabilize dunes or help them to grow, and they furnish large amounts of debris to be cleaned up after beach storms. These pines are best removed and replaced

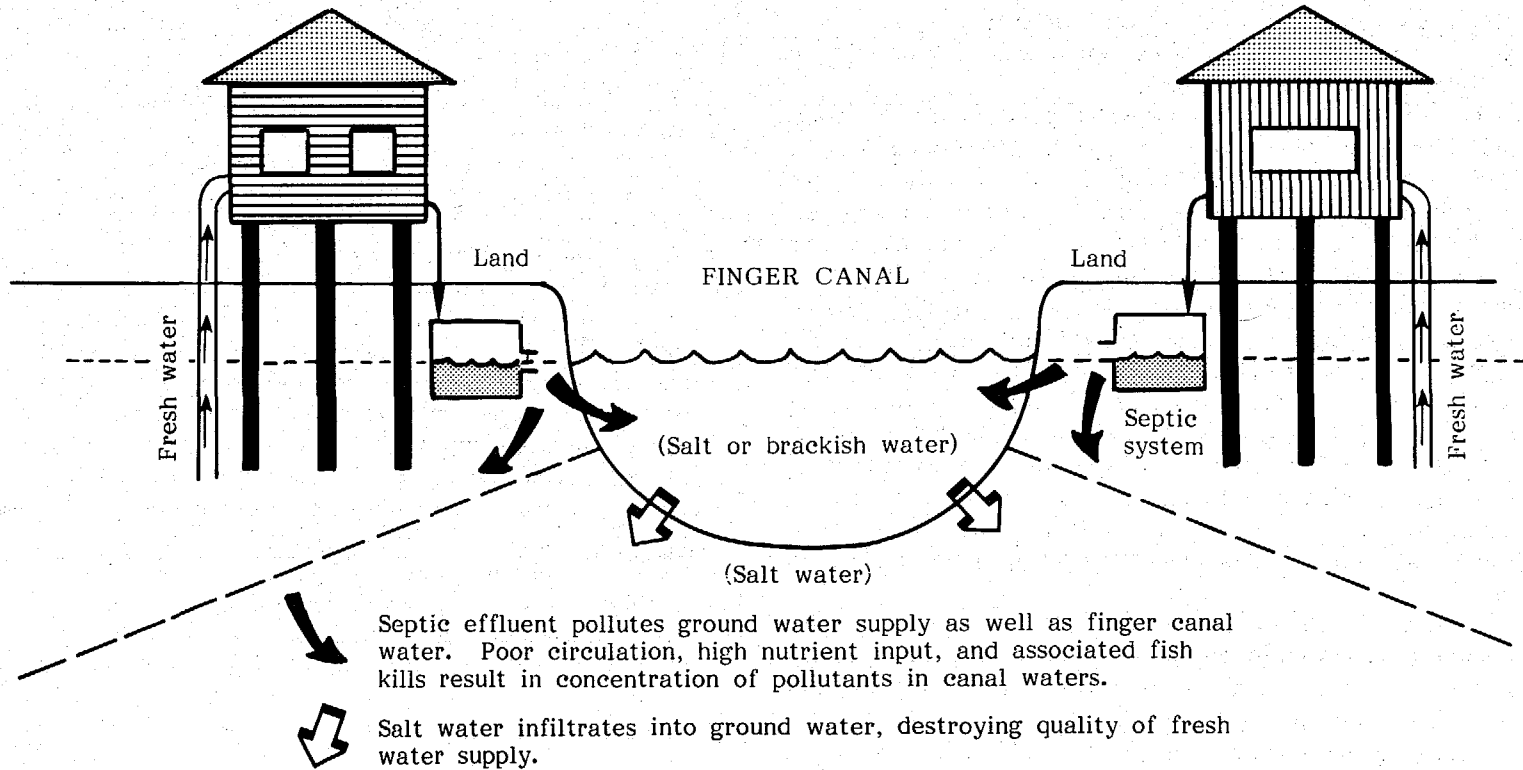
Fig. 5.12. A finger canal system.

Finger canals. A very common man-made island alteration in West Florida is the finger canal (fig. 5.12). Finger canal is the term applied to the ditches or channels dug from the lagoon or bay side of an island into the island proper for the purpose of providing

everyone with a waterfront lot. Canals can be made by excavation alone, or by a combination of excavation and infill of adjacent low-lying areas (usually marshes).

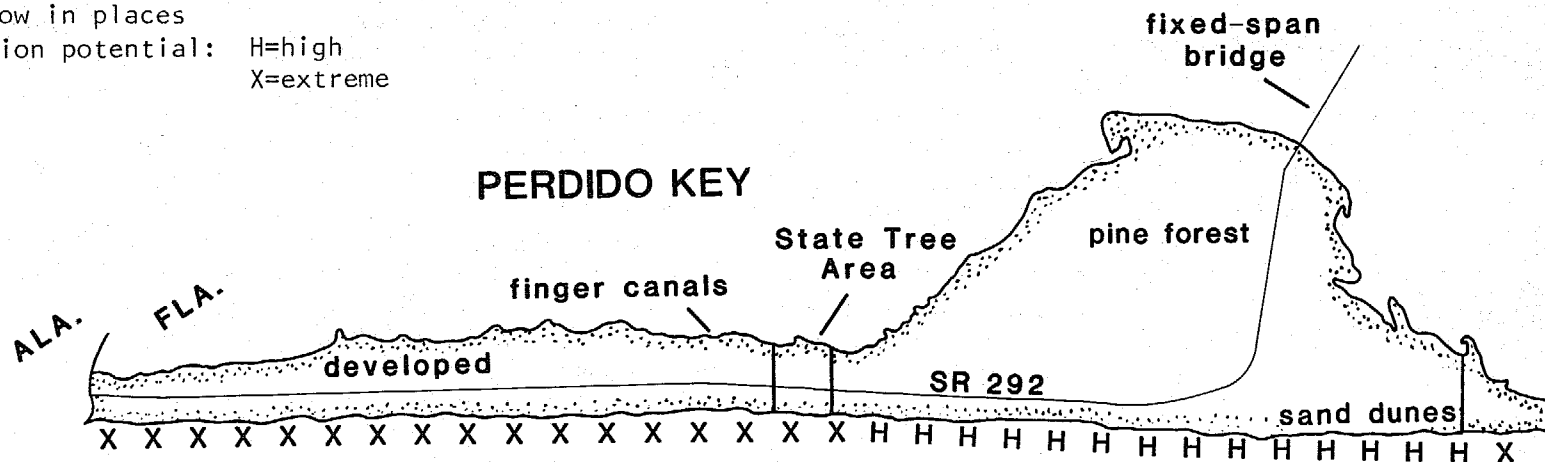
low
narrow in places
erosion potential: H=high
X=extreme

Fig. 5.13. Site analysis map: Perdido Key.

The 13.5 miles of Perdido Key (fig. 5.13) that lie in Florida contain the westernmost beaches in Florida. The reference map shows that with the exception of a 1.5-mile stretch about 3,000 feet wide, the 2,930-acre island is low and narrow. Beaches on the Gulf side vary in width from about 50 feet to 75 feet, and dunes are usually less than 10 feet high. Santa Rosa Island is east of Perdido Key, lying across most of the entrance to Pensacola Bay (figs. 5.14–5.16). Slightly more than 26 miles of this island lies in Escambia County and 3.1 miles in Santa Rosa County. Like Perdido Key, Santa Rosa Island is narrow over much of its length. Dunes range from heights of 6 to 7 feet on the ends to between 8 and 12 feet in the center. Sand bodies 30 to 35 feet high around Fort Pickens appear to be associated with old gun emplacements. The beaches of Santa Rosa Island are somewhat wider than those of Perdido Key, ranging up to about 125 feet. The foreshore and offshore profiles of both islands are relatively steep. Santa Rosa Island and Perdido Key had well-vegetated and anchored dunes before the overwash and flooding during Hurricane Frederic (1979) destroyed most of the dune grasses.

During Hurricane Frederic in 1979 storm surges of 14.0 feet and 12.0 feet above mean sea level were recorded at Perdido Key and Pensacola Beach, respectively. More than 90 percent of Santa Rosa Island and Perdido Key were under water. Eastern Santa Rosa Island suffered dune erosion and extensive washover. There was substantial damage to Fort Walton Beach pier and several dune walkways. But there was minor damage to many of the buildings due to good setbacks and distance from the center of the hurricane. Eglin Air Force Base property had 3 washover fans and minor to moderate dune erosion. At Navarre Beach the man-made channel was breached. Navarre pier suffered extensive damage to the outer 100 feet and 28 pilings. The outer pier deck was 18.0 feet above mean sea level and was damaged by wave uplift forces—indicating wave crest elevation of greater than 18 feet.

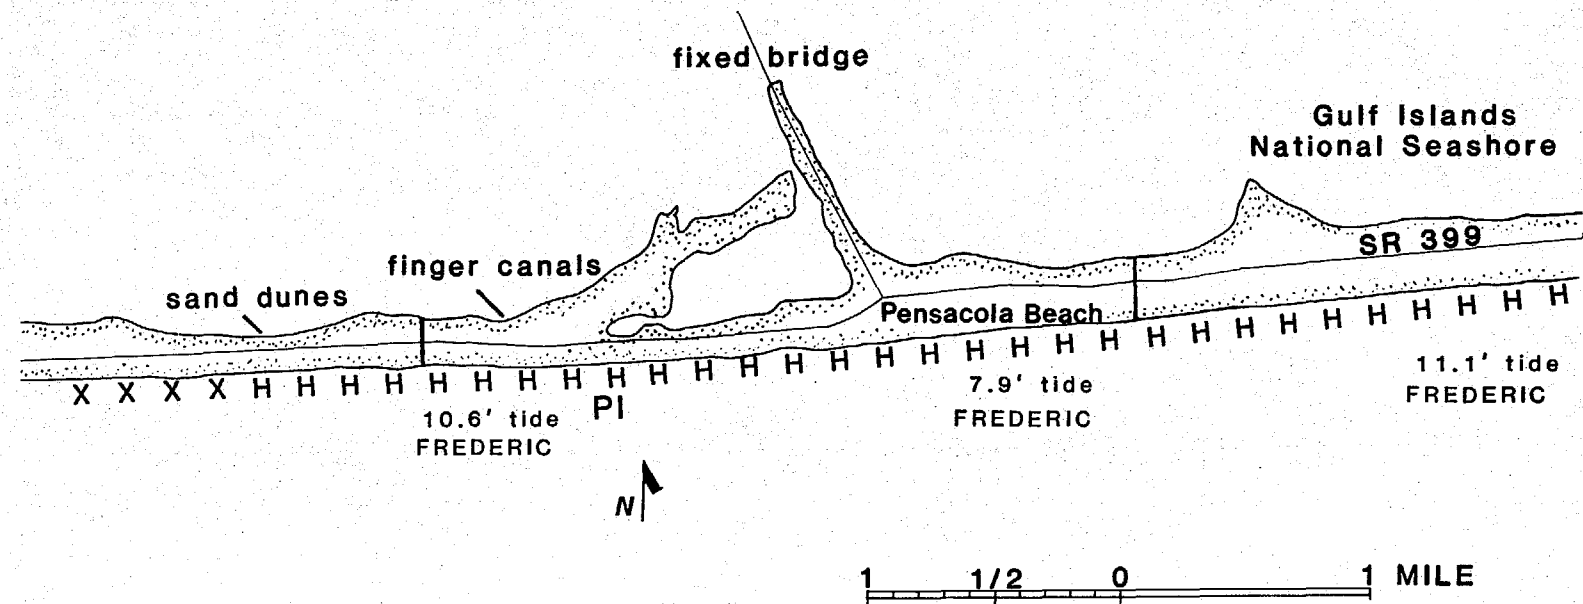
evacuation difficult
low
arrow in places
artificially stabilized

Fig. 5.14. Site analysis map: western Santa Rosa Island.

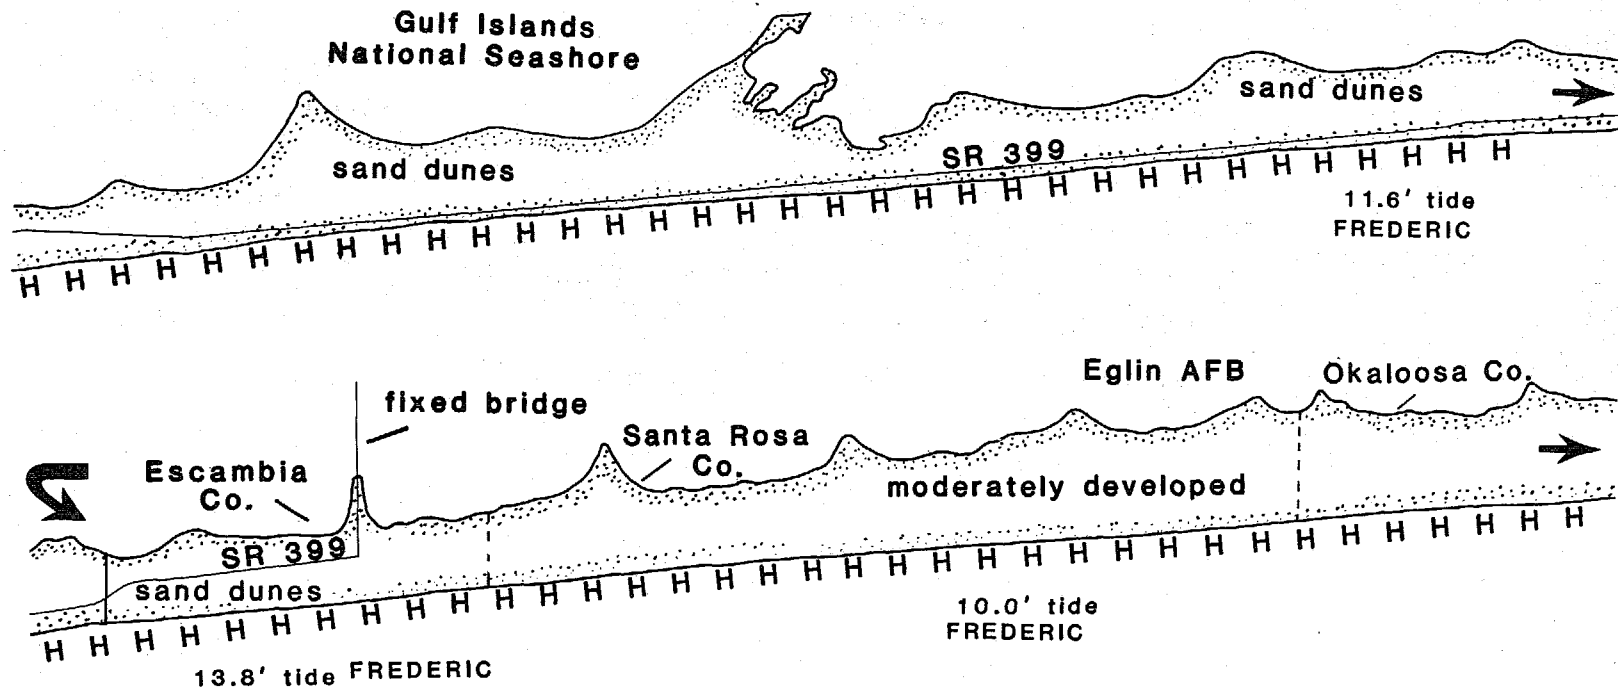
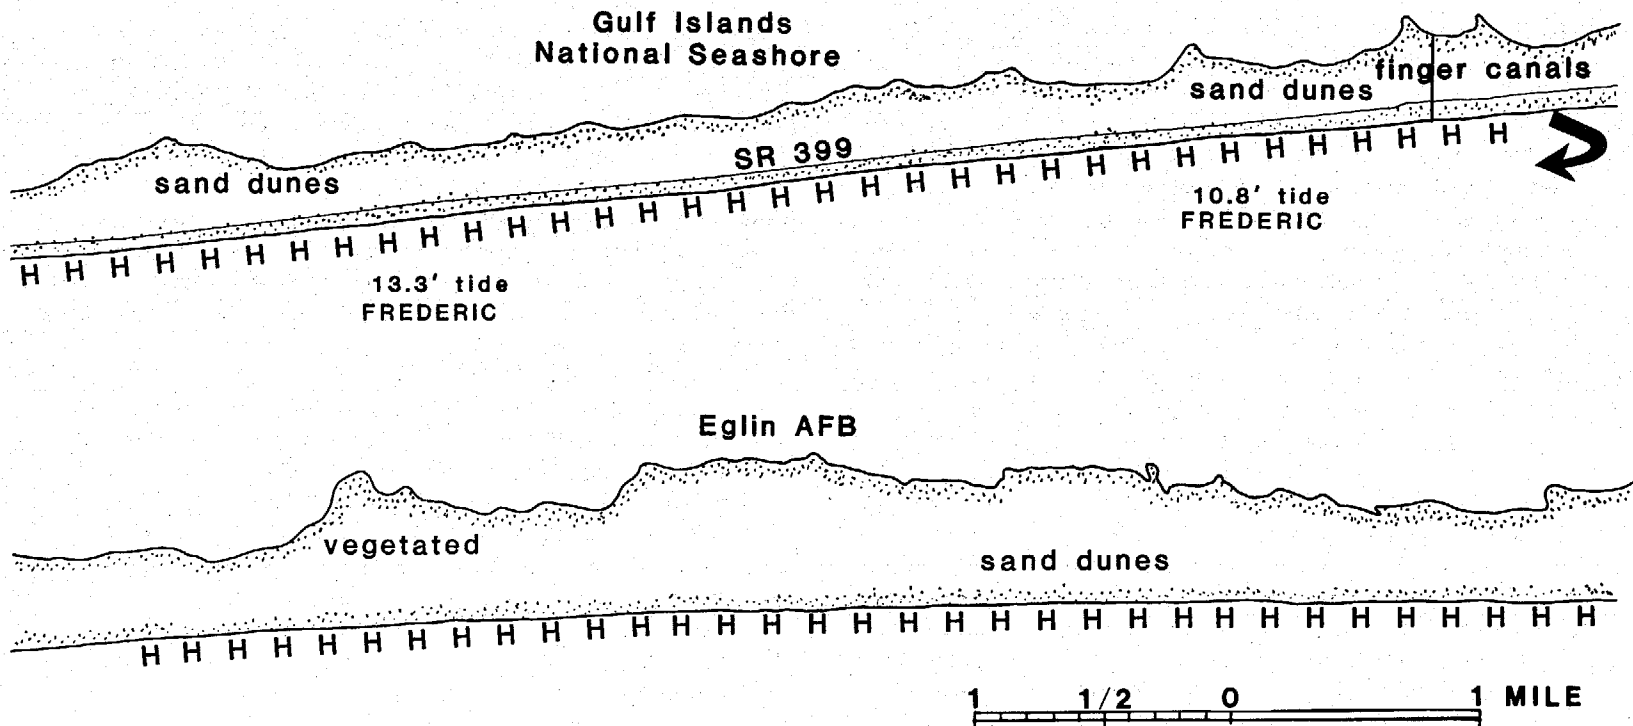
Fig. 5.15. Site analysis map: central Santa Rosa Island.

The Gulf of Mexico shoreline of Okaloosa County has 25 miles of beaches: about 18 miles of barrier beach on Santa Rosa Island west of the East Pass navigational channel (figs. 5.15 and 5.16), 2 miles of barrier spit east of the East Pass channel, and about 5 miles of beaches on the Moreno Point Peninsula (fig. 5.17). The Santa Rosa Sound–Choctawhatchee Bay shoreline has 45 miles of beaches and 43 miles of marshy shoreline.

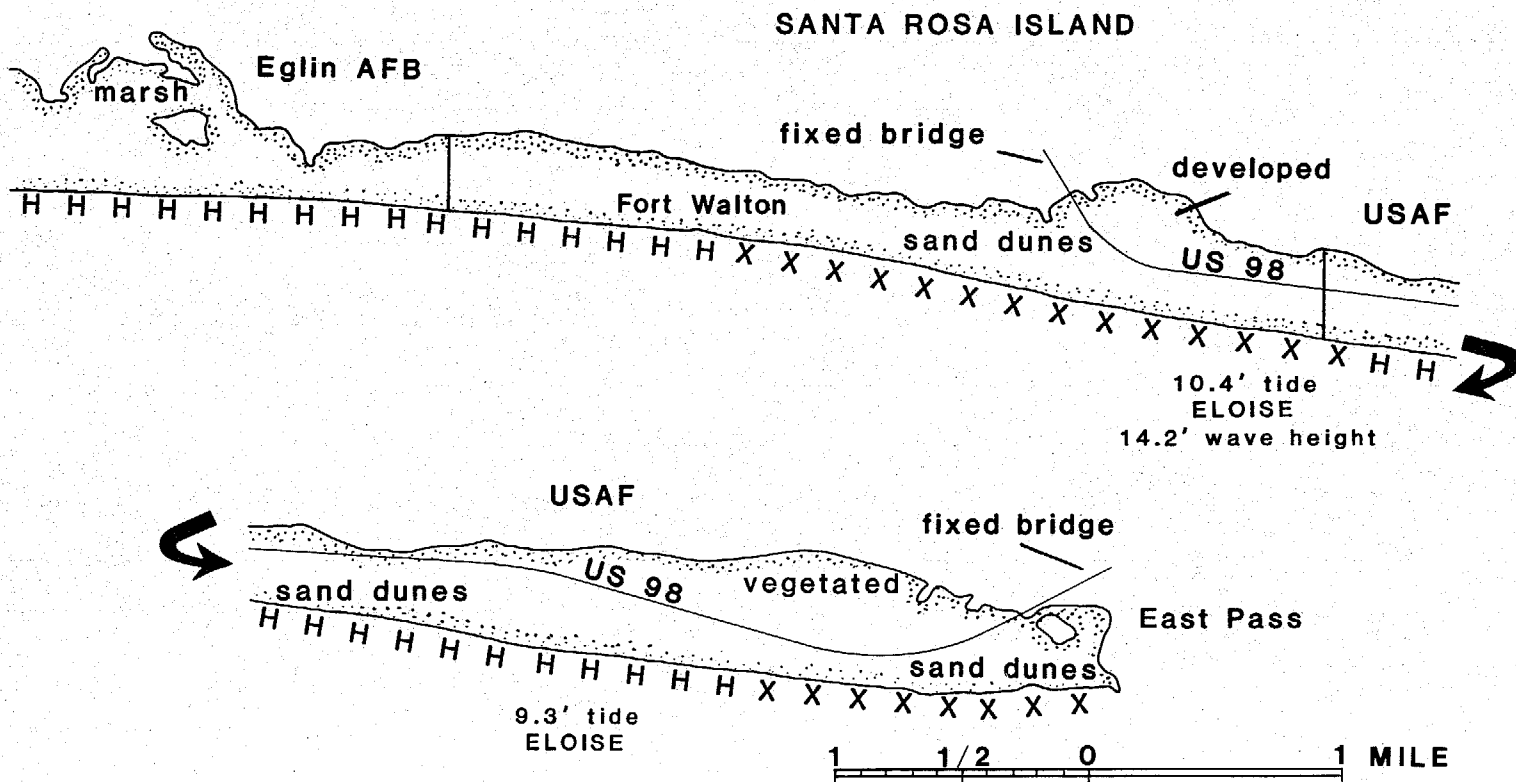
Fig. 5.16. Site analysis map: eastern Santa Rosa Island.

The beaches along the Gulf are generally wide and flat, backed by foredunes 6 to 12 feet high with even higher primary dunes. For a distance of 2 miles on either side of the East Pass channel the beaches lack foredunes or primary dunes. The shoreline of Choctawhatchee Bay in Okaloosa County is primarily sandy beach with a low berm somewhat narrower than that of the Gulf beaches.

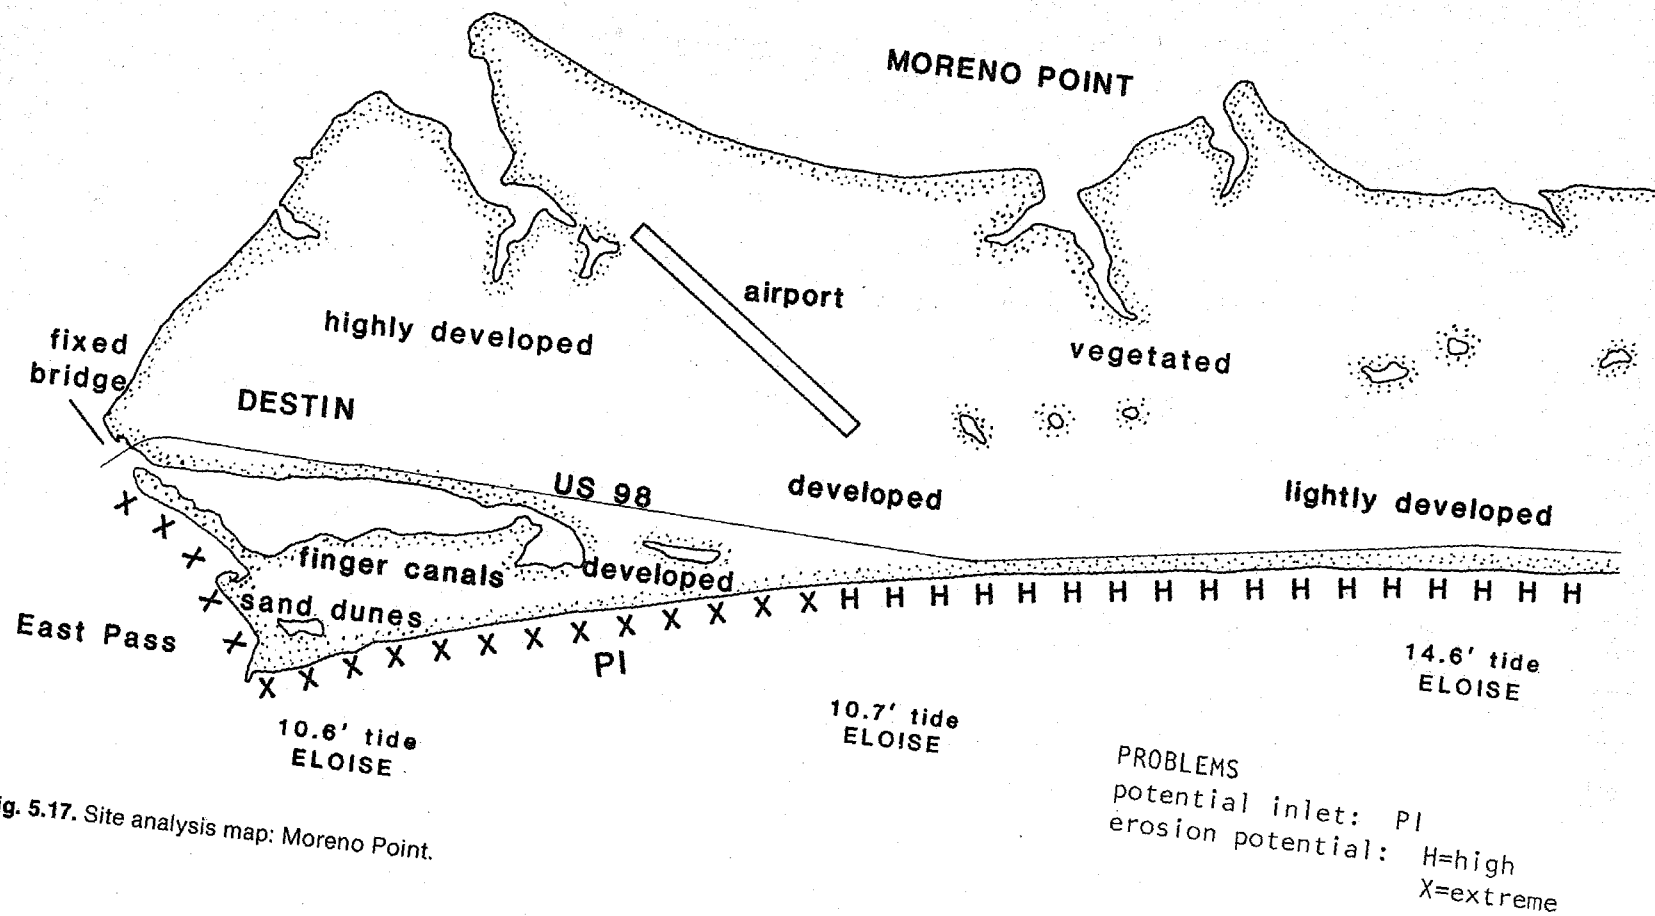
Fig. 5.17. Site analysis map: Moreno Point.

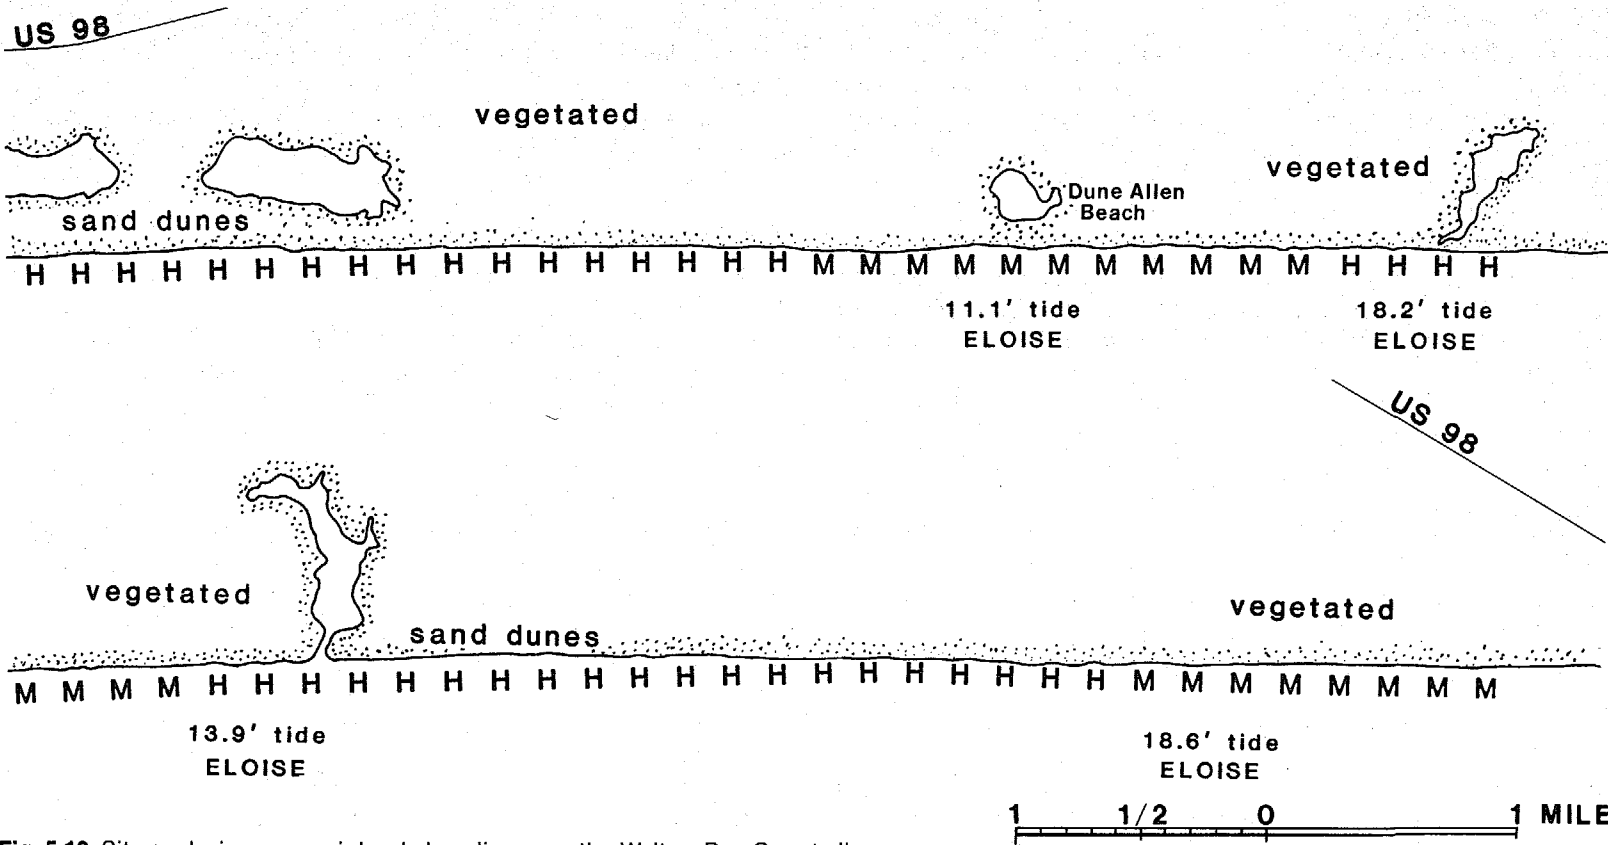
Fig. 5.18. Site analysis map: mainland shoreline near the Walton-Bay County line.

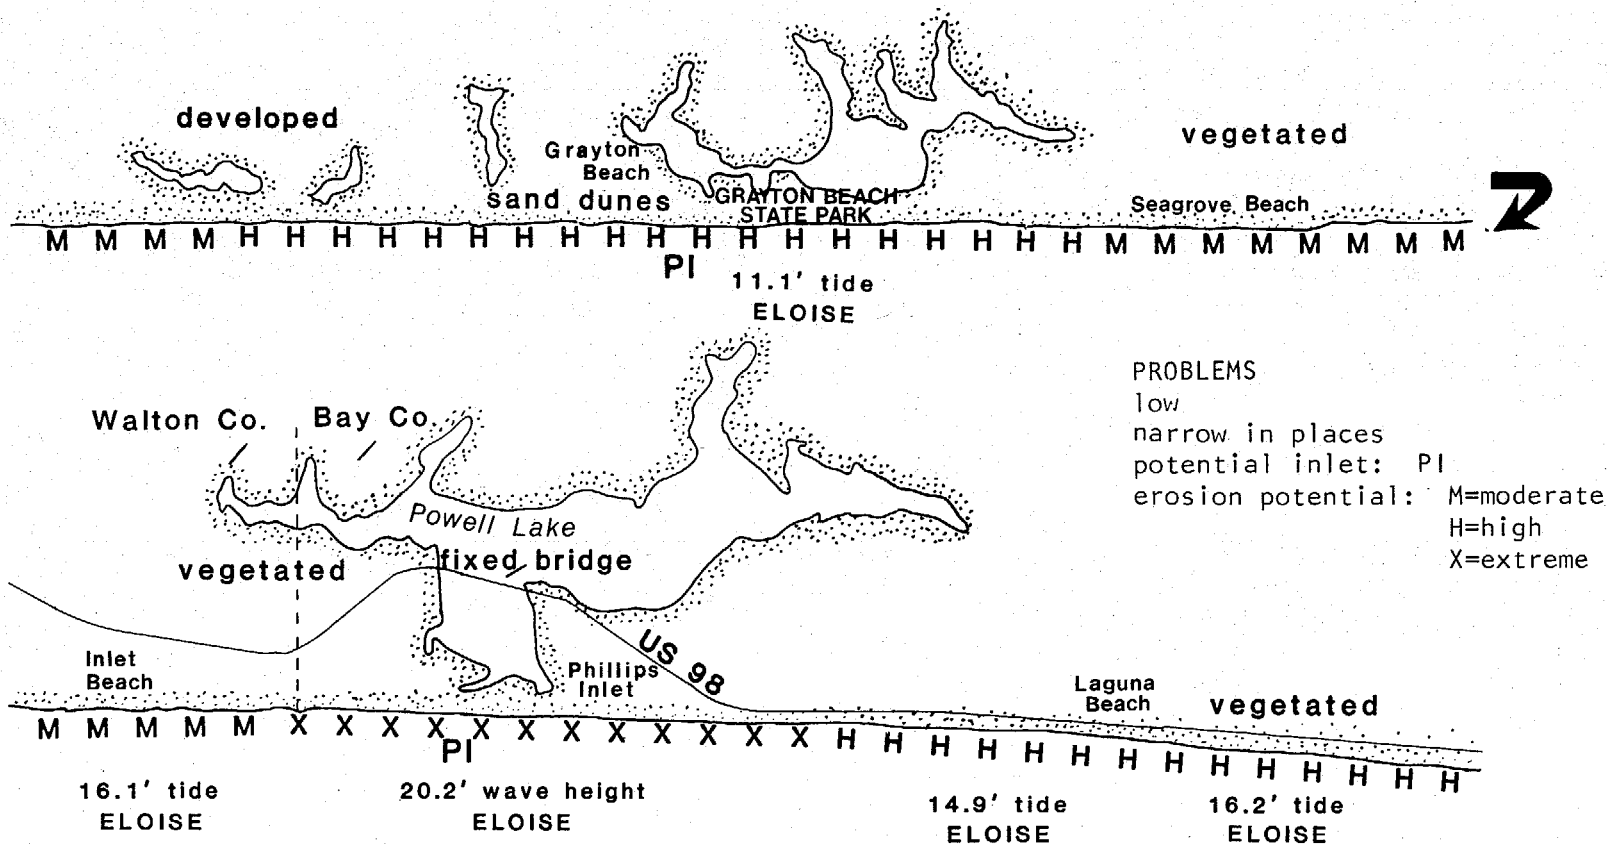
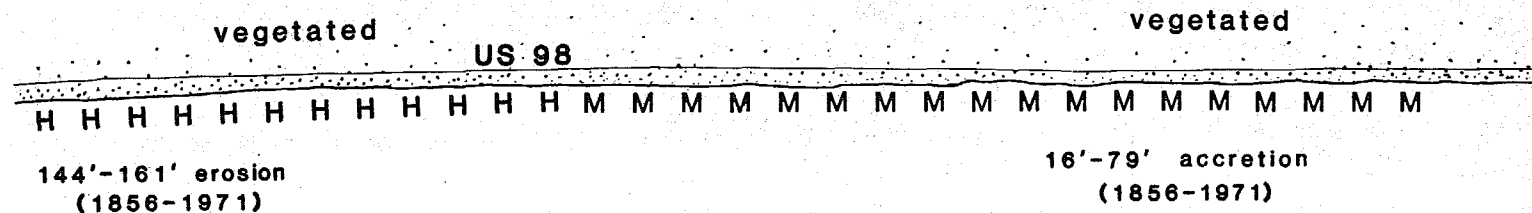
Fig. 5.19. Site analysis map: area around St. Andrews State Park.

The entire 18.4 miles of Bay County beaches west of the jetties have experienced gradual retreat since records have been kept. According to the Army Corps of Engineers, from St. Andrew State Park to Oriole Street (2.5 miles west; fig. 5.19) the beaches retreated 187 to 97 feet during the period from 1856 to 1971, with an overall erosion rate of 0.7 feet per year for the whole stretch. From Biltmore Beach west to a point east of Bahama Beach, shoreline retreat has ranged from 127 feet to 16 feet during the 1856–1971 period, with an overall erosion rate of 1.5 to 2.5 feet per year. At the same time a 3-mile section from Bahama Beach to Gulf Resort Beach advanced 16 to 79 feet. The western 6.5 miles to Phillip's Inlet near the borderline between Bay and Walton counties experienced retreat of 51 to 251 feet, most severely along the 2 miles on either side of Phillip's Inlet.

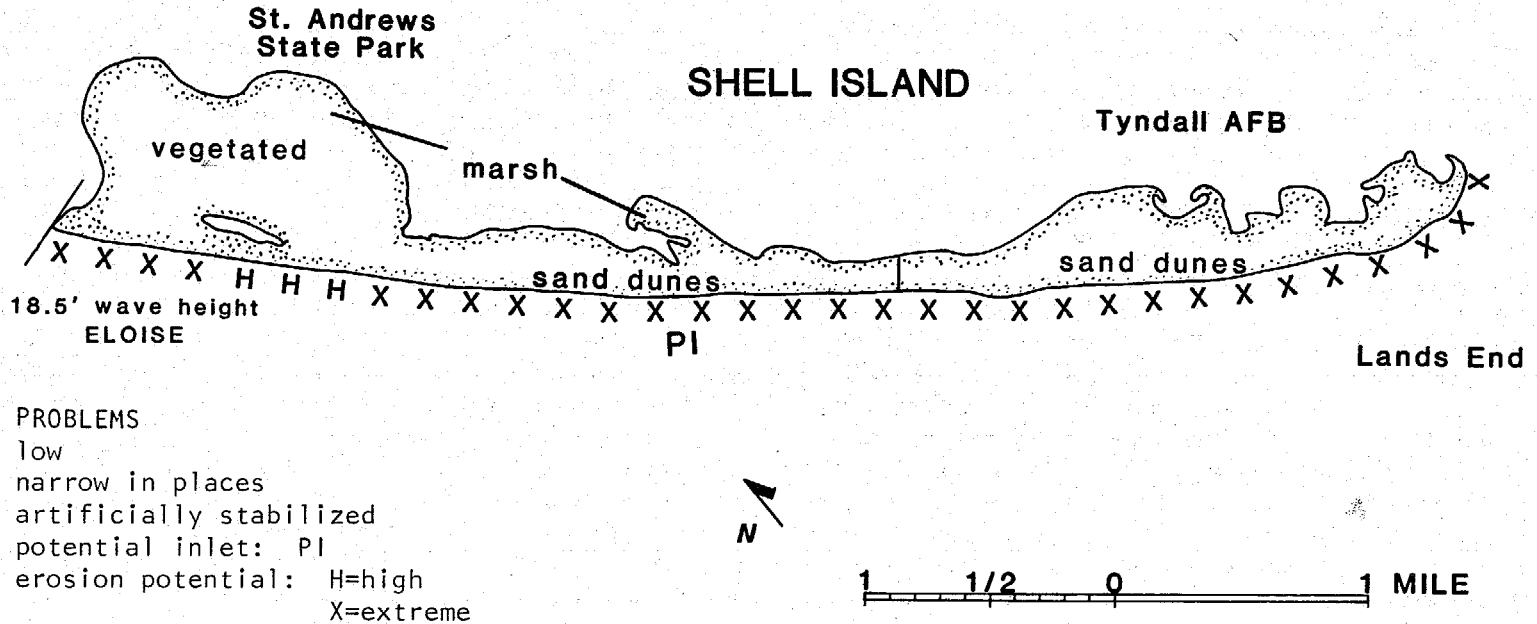
Fig. 5.20. Site analysis map: Shell Island.

Bay County's Gulf of Mexico shoreline is characterized by Shell Island (fig. 5.20) with 11 miles of beachfront, 22 miles of mainland shoreline, and 3,100 acres of land; Dog Island with 2 miles of beaches and about 150 acres; and Crooked Island (fig. 5.21), 9.5 miles long with 1,700 acres.

The barrier beaches are composed of fine quartz sand and shell fragments in varying proportions. Almost all of the mainland and island beaches are backed by dunes that in some cases can be as high as 25 feet and at other times lower than 5 feet. Shell Island is the widest of the barrier islands and has 3 distinct sections. The oldest section is made up of wide dune ridges separated by wide swales containing peat deposits. The section of intermediate age is composed of narrow beach ridges separated by narrow swales that connect the barrier to the mainland. Both sections have elevations of 8 to 12 feet. The youngest deposits comprise the eastern peninsular area, a low beach ridge and narrow sand flat with 5- to 10-foot elevations. Crooked Island, most of which has emerged since 1779, is composed of low beach ridges 5 to 7 feet high at the outward building northwestern end and at the old inlet sites, whereas

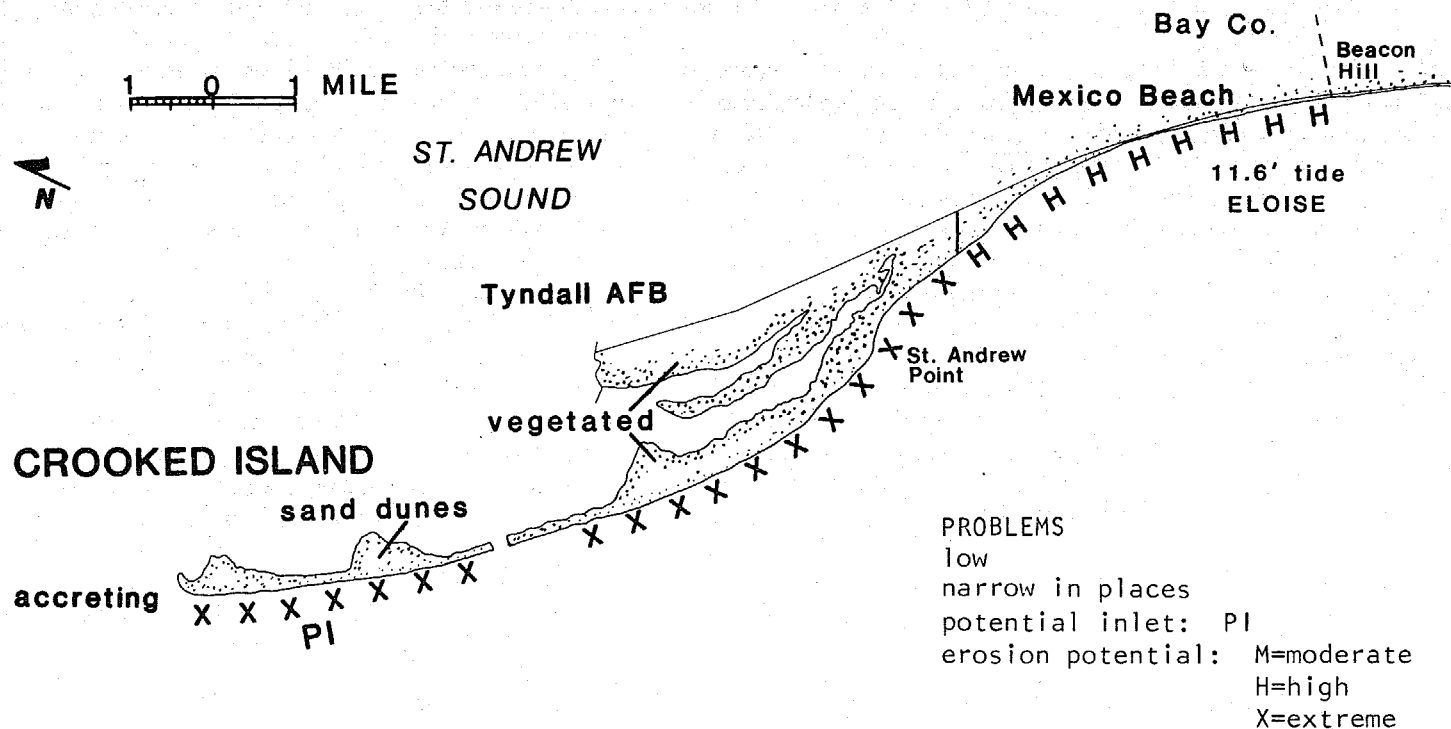
Fig. 5.21. Site analysis map: Crooked Island through Indian Peninsula.

The beaches of Gulf County are characterized by barrier spits at Indian Peninsula and St. Joseph Spit and by mainland beaches. The 3-mile section from the eastern tip of Indian Peninsula to its base at Camp Palm has beaches 90 to 100 feet wide with low dunes. Mainland beaches from Camp Palm to the base of St. Joseph Spit are about 200 feet wide and backed with 10- to 30-foot dunes. For about 3 miles to the west from the base of St. Joseph Spit to Cape San Blas, the headland beach is backed by multiple

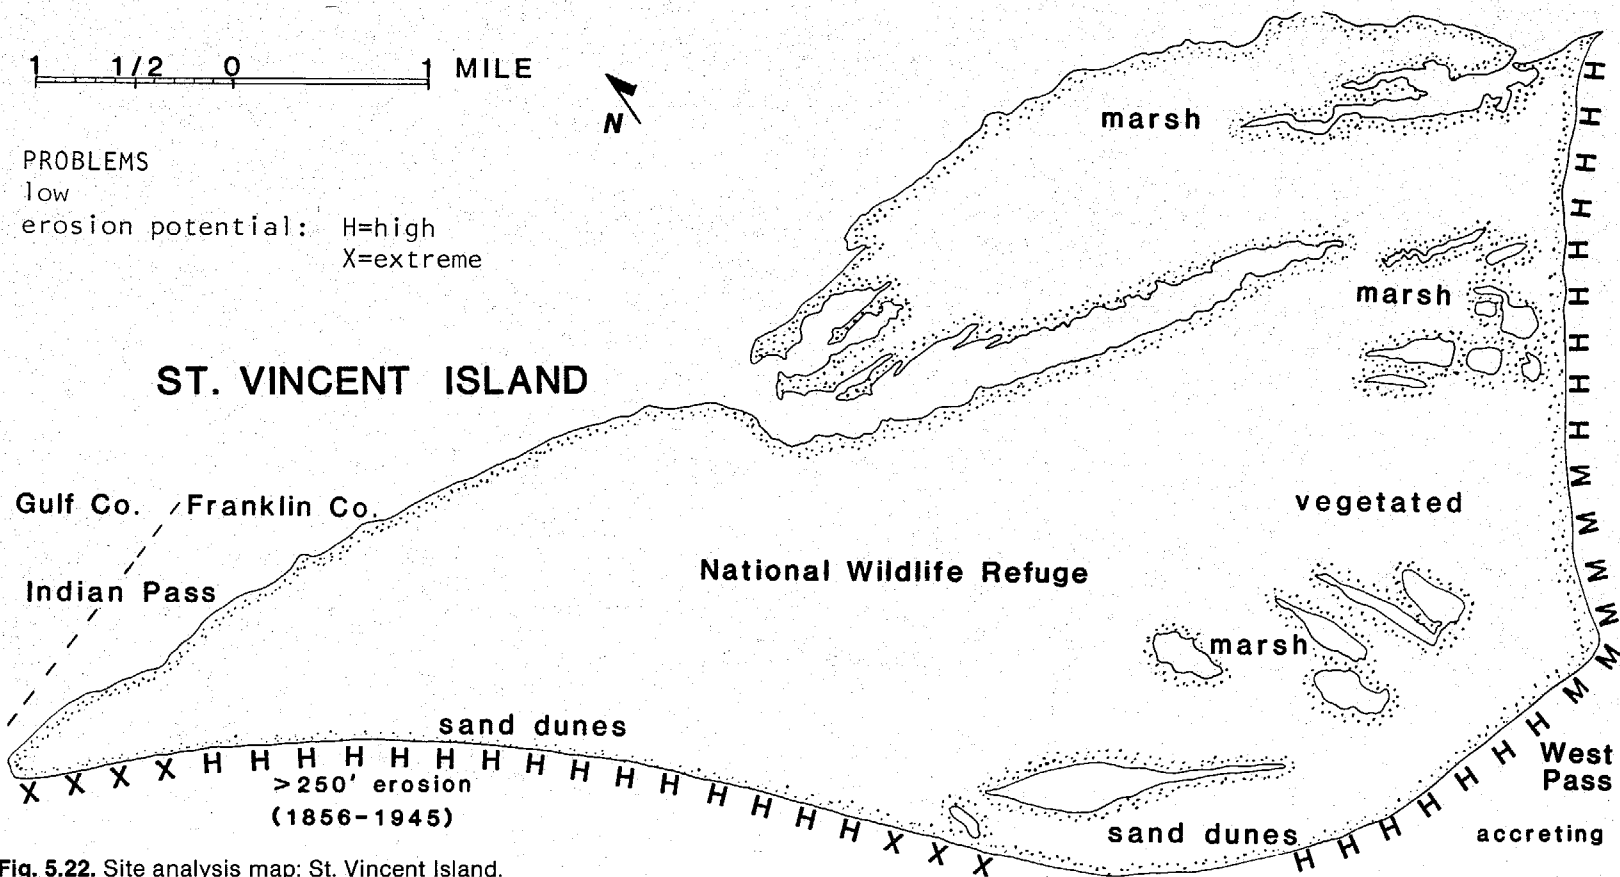
Fig. 5.22. Site analysis map: St. Vincent Island.

St. Vincent Island (fig. 5.22) is an excellent example of dune-and-swale topography and the multiple dune ridges of a natural barrier island. The curved eastern section of the island and the southern shore have wide, sandy beaches with a history of land-

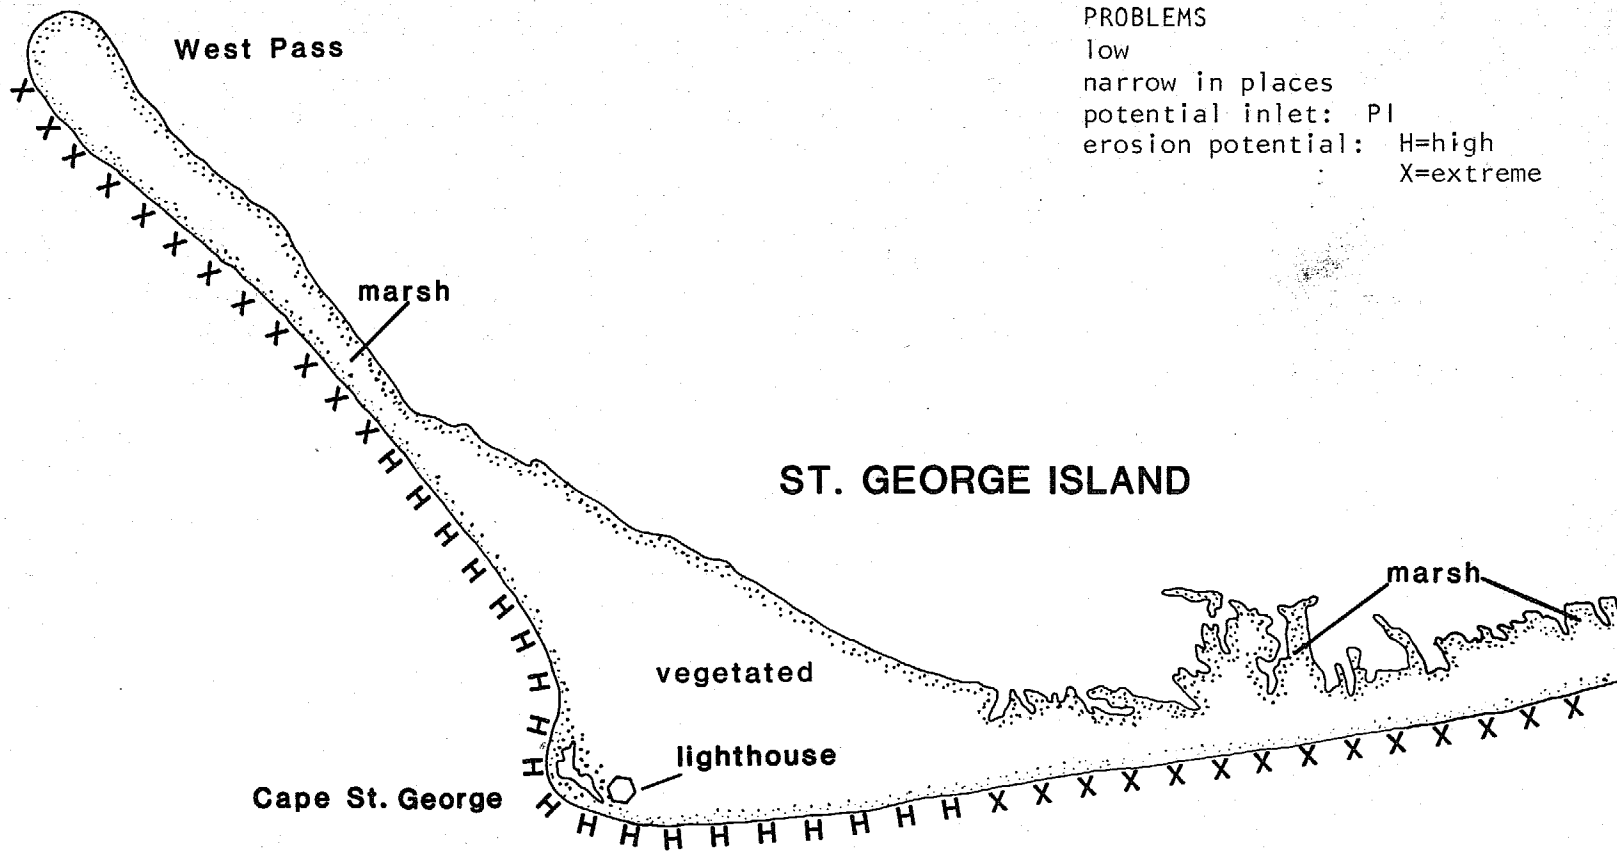
Fig. 5.23. Site analysis map: western half of St. George Island.

St. George Island's (figs. 5.23 and 5.24) eastern end built out-
